Case Study: CH-1330

REFINERY SOLVES LONG TERM CORROSION PROBLEM BY DEPLOYING 3D TRASAR™ TECHNOLOGY FOR CRUDE OVERHEAD SYSTEMS

Case Study: Refining Process Treatment

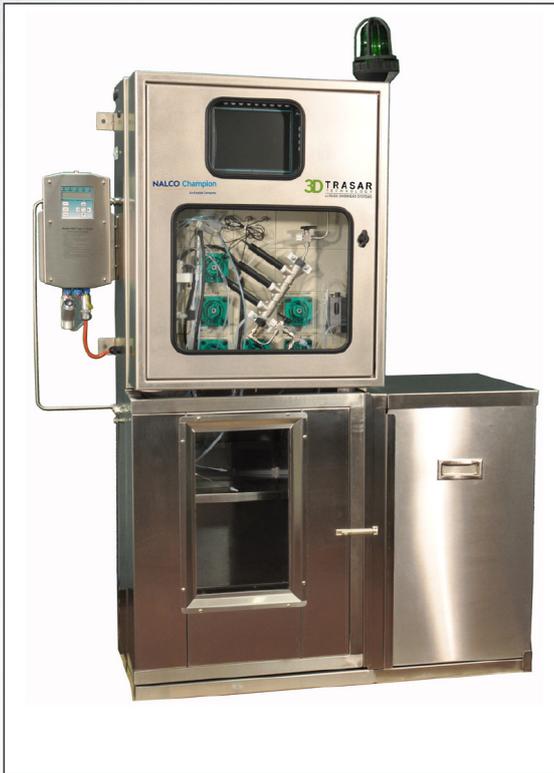
Figure 1: 3DTCOS Equipment

To meet the customer's needs, Nalco Champion deployed the new 3D TRASAR Technology for Crude Overhead Systems. The 3D TRASAR for Crude Overhead Systems analyzer takes a stream of crude unit overhead sour water and in real time determines the corrosive state of this water. Based on this analysis, 3D TRASAR for Crude Overhead Systems analyzer directly controls the addition of caustic, neutralizing amine, and filming inhibitor to the crude unit overhead. The goal is to link the chemical addition directly to the demands of the overhead system. Because this was new technology and yet unproven, 3D TRASAR for Crude Overhead Systems was initially deployed for 18 months in monitoring mode only. No attempt was made to control the addition of chemical additive. During monitoring mode, the goal was to purely observe the system and establish direct linkage between changes in operations and corrosion performance.
